USAAVLABS TECHNICAL REPORT 65-38

COMPONENT TESTING XV-9A HOT CYCLE RESEARCH AIRCRAFT SUMMARY REPORT

CONTRACT DA 44-177-AMC-877(T)
HUGHES TOOL COMPANY

This report was prepared by the Hughes Tool Company, Aircraft Division, under the provisions of Contract DA 44-177-AMC-877(T) to document service life substantiation of various critical components of the XV-9A aircraft. The test objectives were completed with generally satisfactory results.

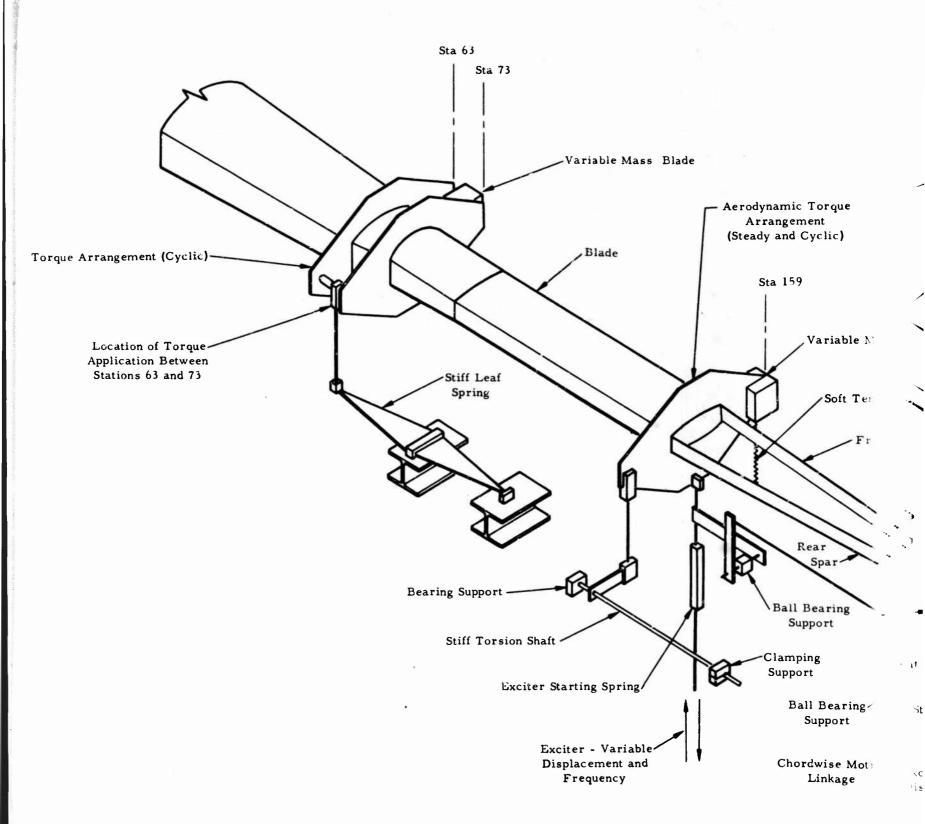
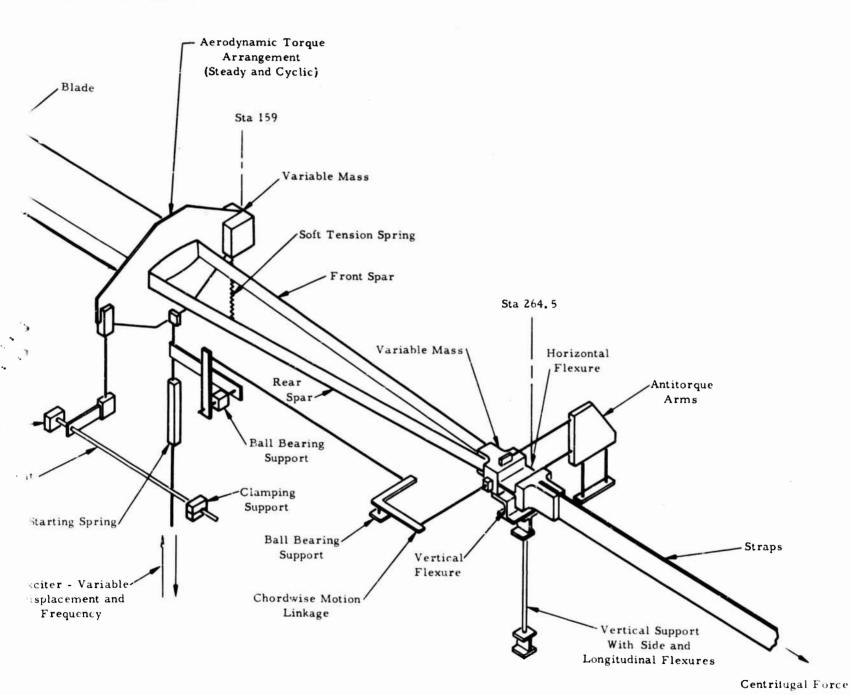
Figure 55. Blade Root-End Fatigue Test - Loading

Blade Root-End Fatigue Test - Loading Schematic.

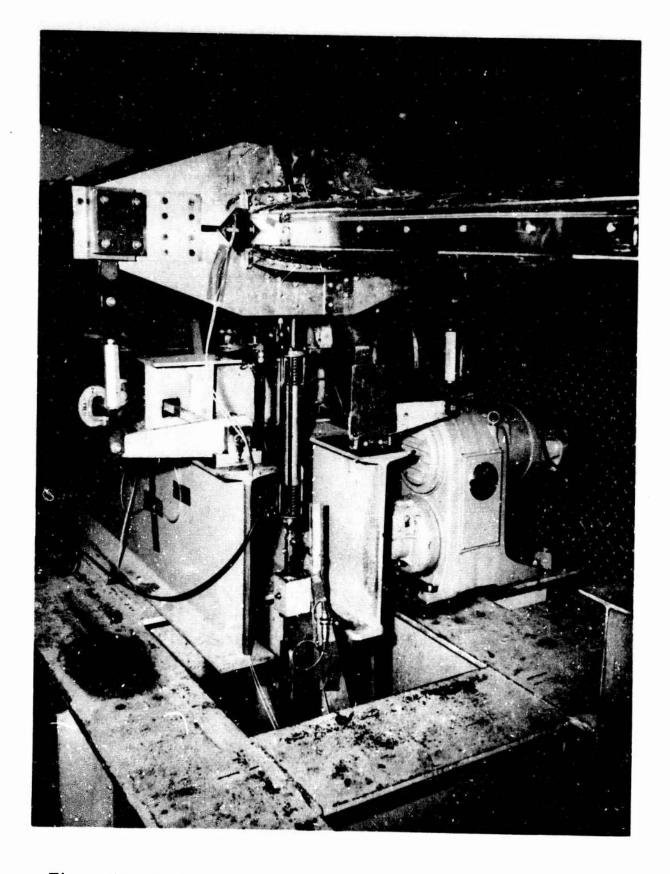
Figure 57. Blade Root-End Fatigue Test Fixture - Drive System.

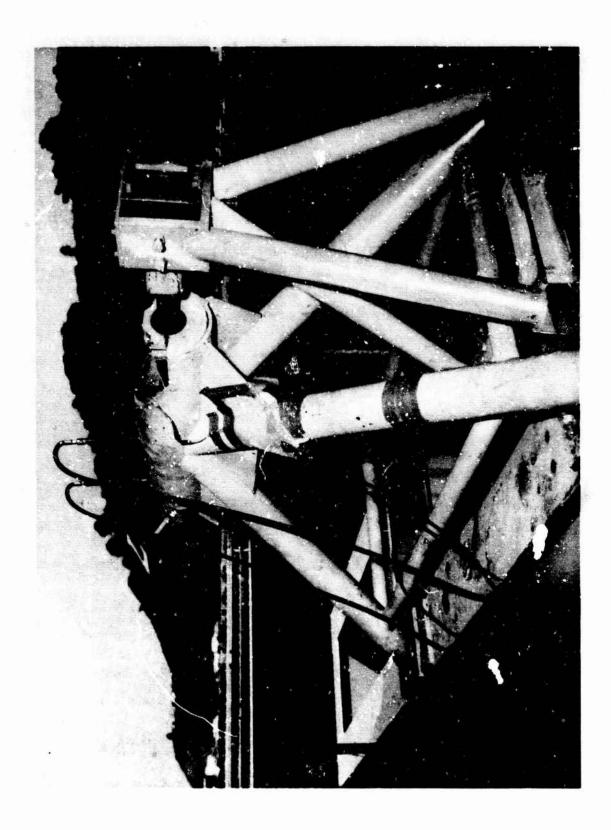
Figure 59. Blade Root-End Fatigue Test Fixture - Centrifugal Loading System.

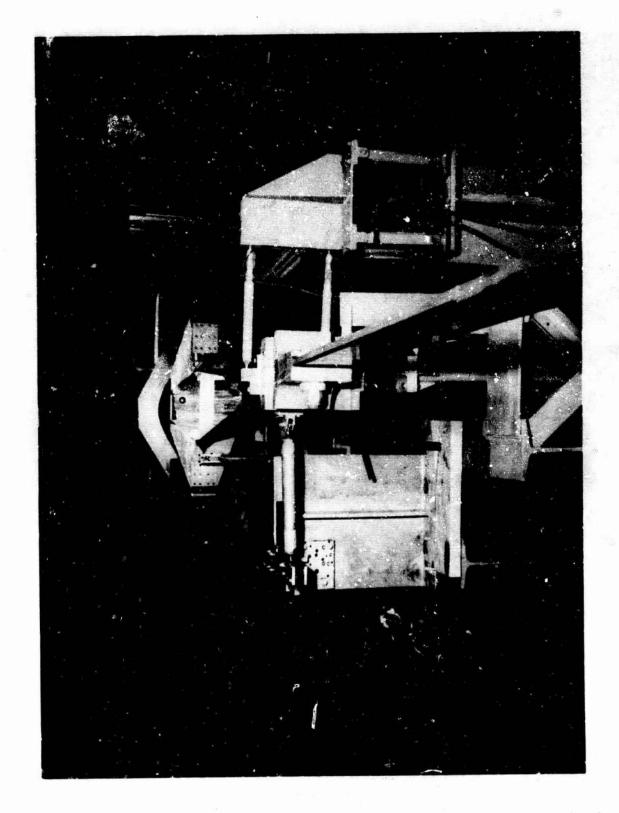
Figure 60. Blade Root-End Fatigue Test Fixture - Chordwise Input Mechanism.

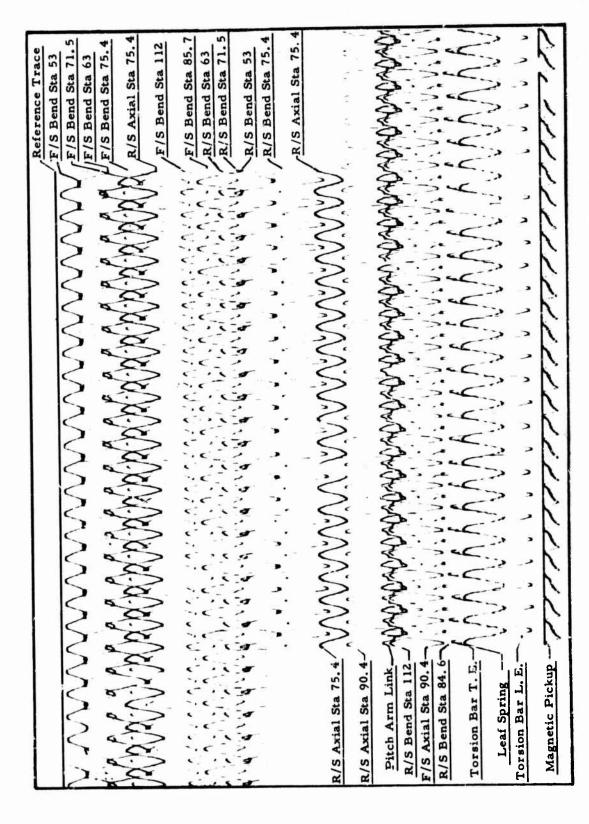
Figure 63. Blade Root-End Fatigue Test - Oscillograph Record at Test Load Level,

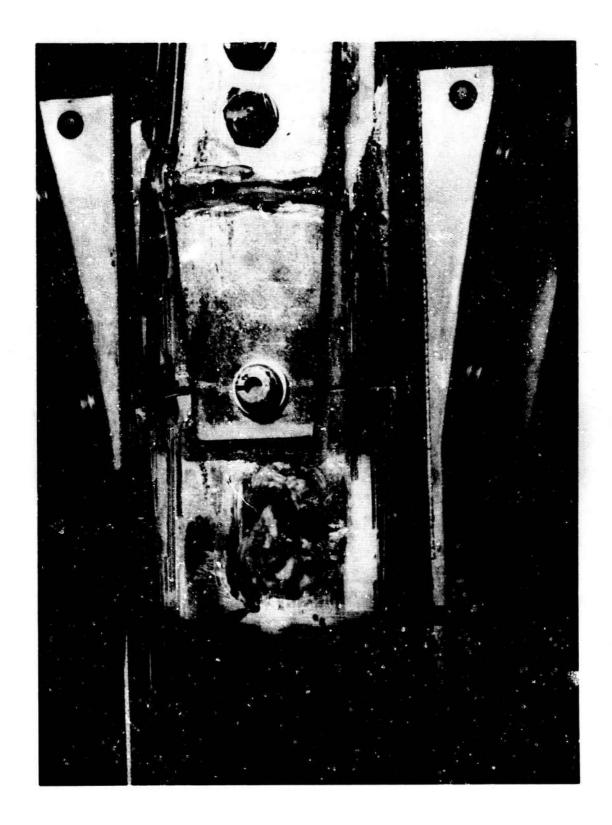
- 2. On the front spar, at station 90, the five most outboard laminations were cracked. See Figure 65.
- 3. Cracks were found in the laminations next to the segments at several of the attaching bolt holes. See Figure 66.
- 4. Holes for the bolts attaching the spars to the segments were cocked as much as 4 degrees, due to the lamination slipping during the bonding operation. (This manufacturing discrepancy was corrected and does not exist on the flight blade spars.)
- 5. Holes in the segments were also found to be oversize on the test specimen.
- 6. Failure of the bond between the root-end fitting and the spar at the first bolt was noted (at approximately station 90).

Figure 65. Blade Root-End Fatigue Test - Front Spar Fatigue Crack.

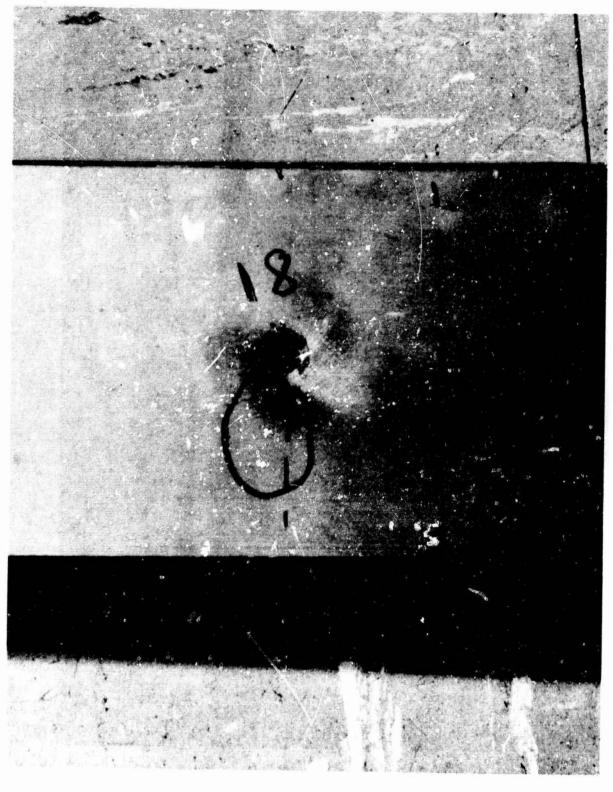
Figure 66. Blade Root-End Fatigue Test, Rear Face of Spar, Fatigue Crack.

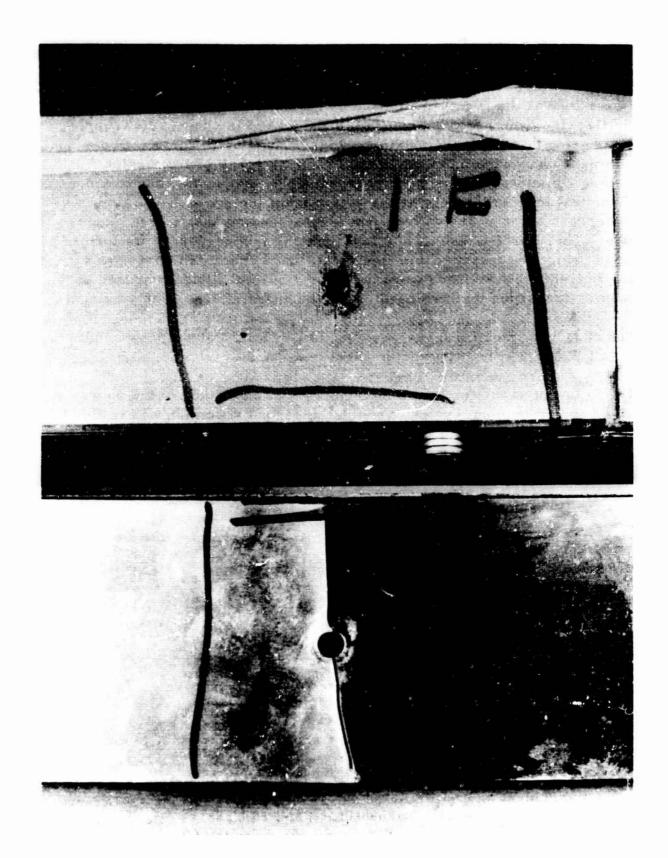
- 1. The most serious failure was in the first two laminations on the segment side of the front spar at station 94.12, which failed completely across their width. They are shown in Figure 67.
- 2. Other minor cracks in the first lamination on the segment side of the forward spar were located through holes at stations 106.68 and 131.68. A typical crack is shown in Figure 68. Figure 69 shows the condition of the segment side of the forward spar and its mating area on the segments.

Figure 67. Cracked Laminations in Front Spar at Station 94.12, Specimen 2.

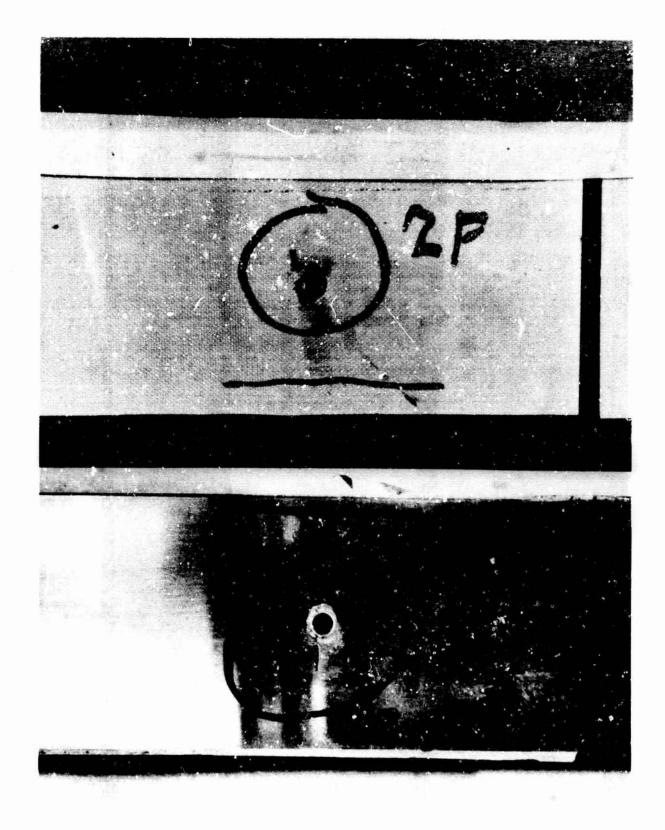
Figure 68. Typical Crack Found on the Segment Side of the Front and Rear Spars, Specimen 2.

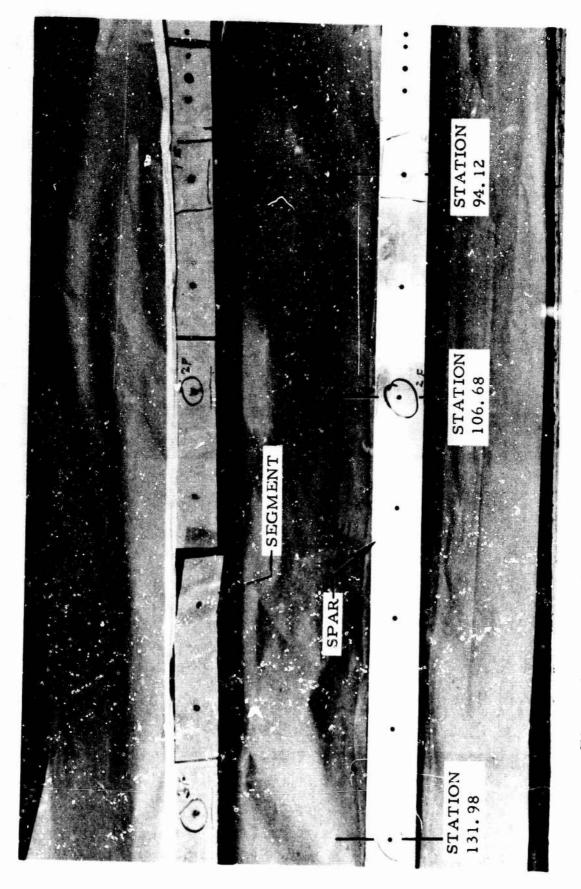
Figure 69. View of Segment Side of Front Spar Showing Location of Three Holes Where Cracks Occurred, Specimen 2.

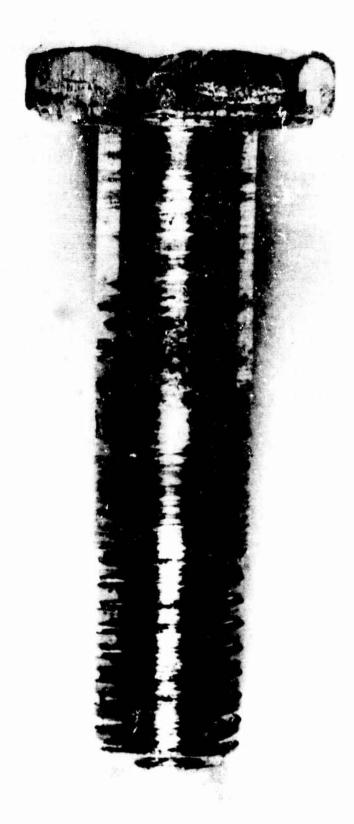
- 3. Cracks in the first lamination on the segment side of the rear spar were minor, and were located at stations 74.62, 94.12, 119.12, and 144.12. They are not shown in detail, because Figure 68 is typical of their appearance.
- 4. Several spar-to-segment bolts (NAS 464, 1/4-inch dia) broke during the initial 250, 000 cycles. They failed in different areas one at the head, others at the root of the last imperfect thread. Conditions of typical bolts after test are shown in Figures 70 and 71.

Figure 70. Appearance of Bolt Removed From Station 94.12, Forward Spar, Where Major Cracks Occurred, Specimen 2.

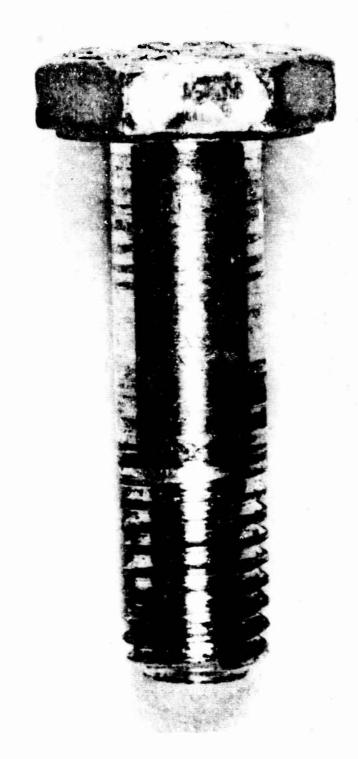
Figure 71. Appearance of Typical Bolt Removed From Segment Holes Where No Cracks Had Occurred, Specimen 2.

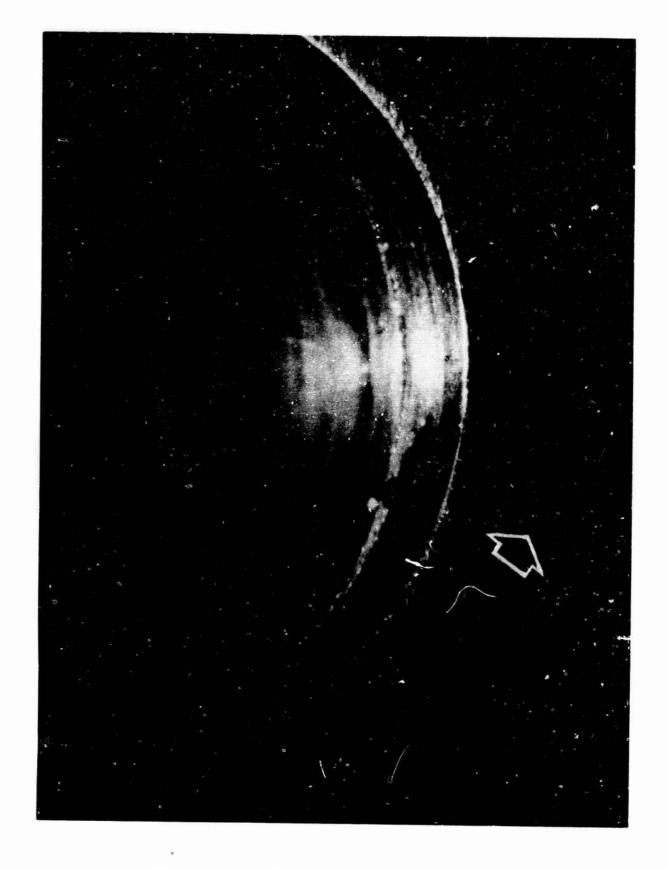
Figure 78. View of Rear Spar Fatigue Crack and Inside Bolt Hole.

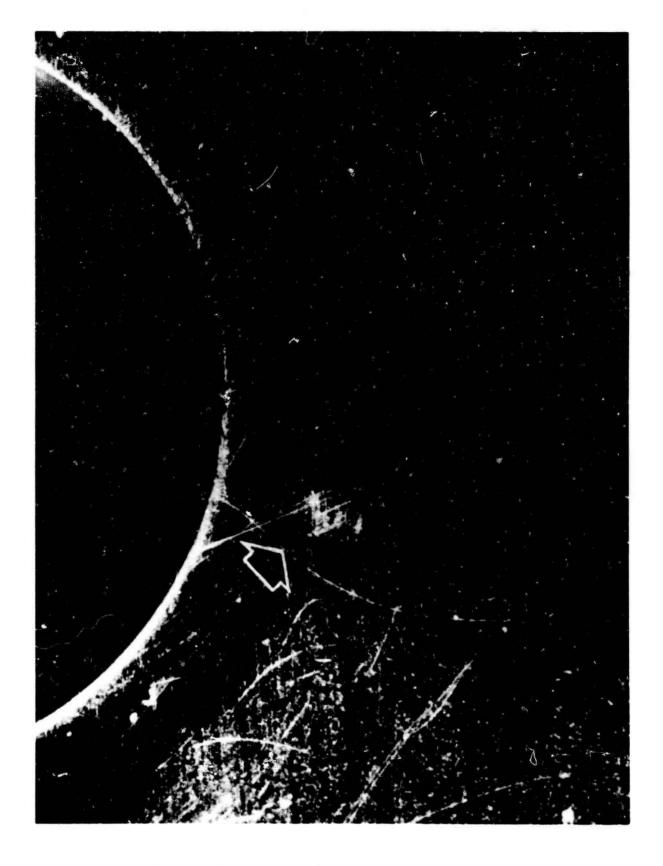
Figure 79. View of Rear Spar Fatigue Crack.

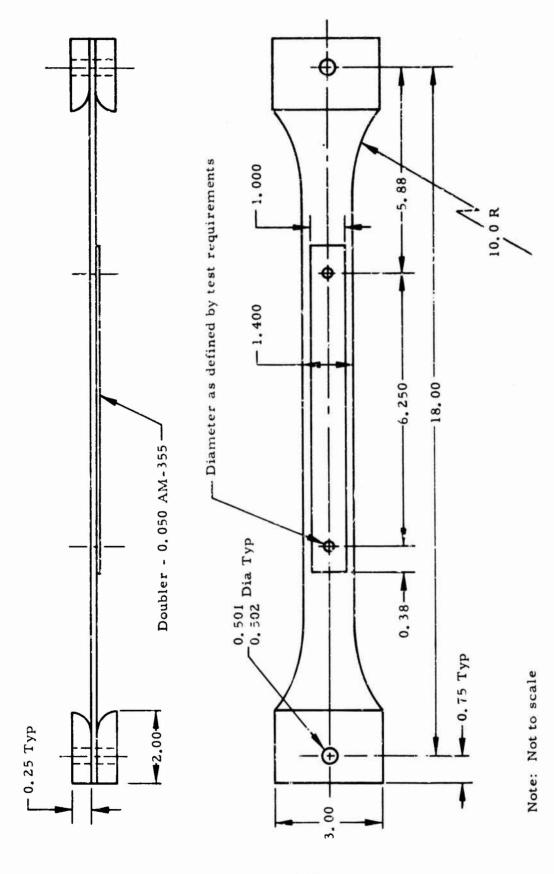
The test specimens were designed to simulate two areas of the blade spar: the segment-to-spar constant section area and the root-fitting-to-spar area, blade station 90. The basic configuration is shown in Figures 80 and 81. The doubler was attached to the specimen to simulate the restraint of the segment on the spar bolt holes when centrifugal force was applied. Various modifications of flanged and countersunk bushings were installed in the bolt holes for all configurations, as shown in Figures 82 and 83.

Figure 80. Segment-to-Spar (Two-Hole) Fatigue Specimen.

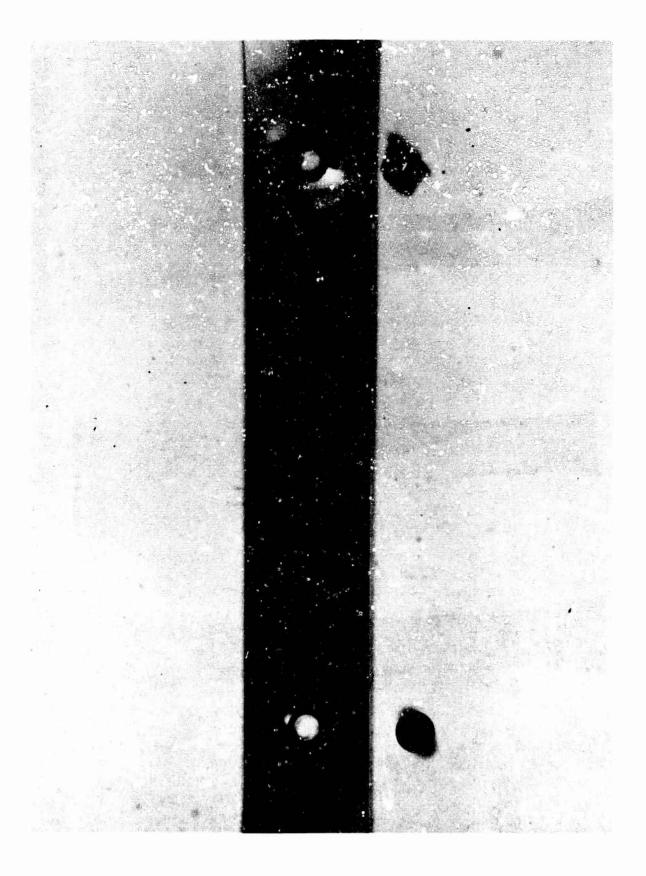
Figure 82. Typical Countersunk Threaded Bushing, Specimen 17.

The undercut shank, threaded, countersunk bushing installation was found to be superior in fatigue strength. This superiority was the

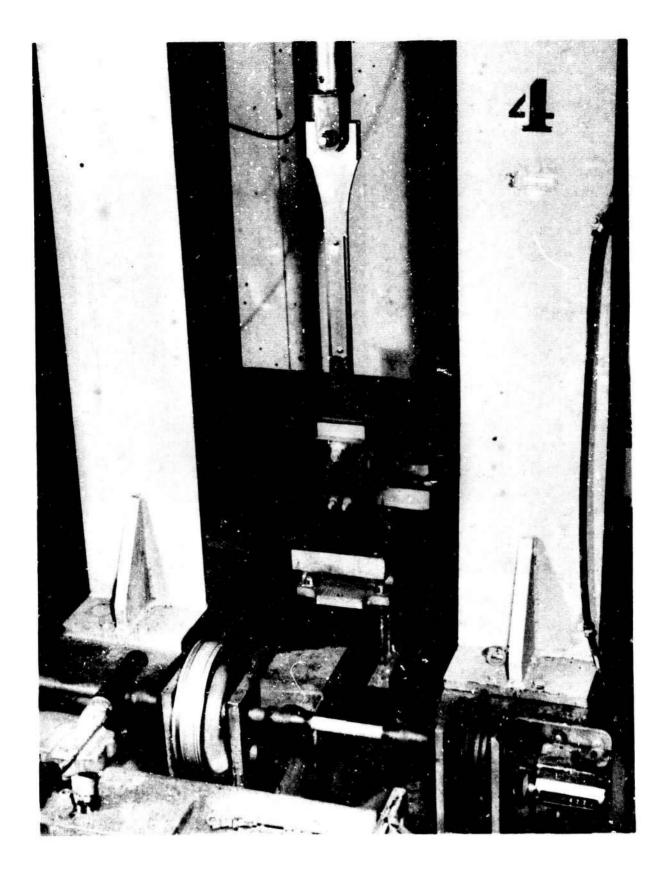
Figure 84. Two-Hole Specimen Test Setup.

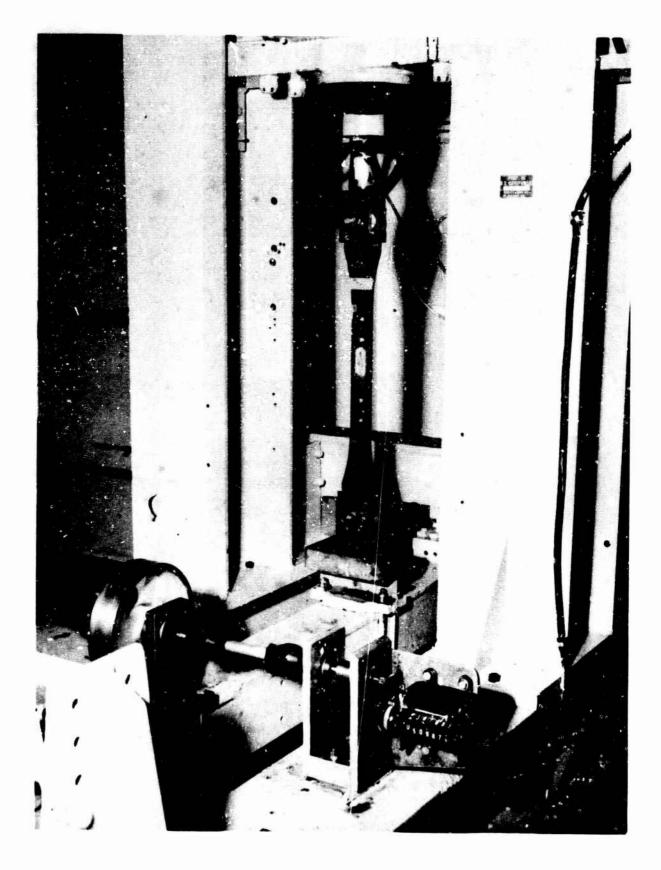
Figure 85. Four-Hole Specimen Test Setup.

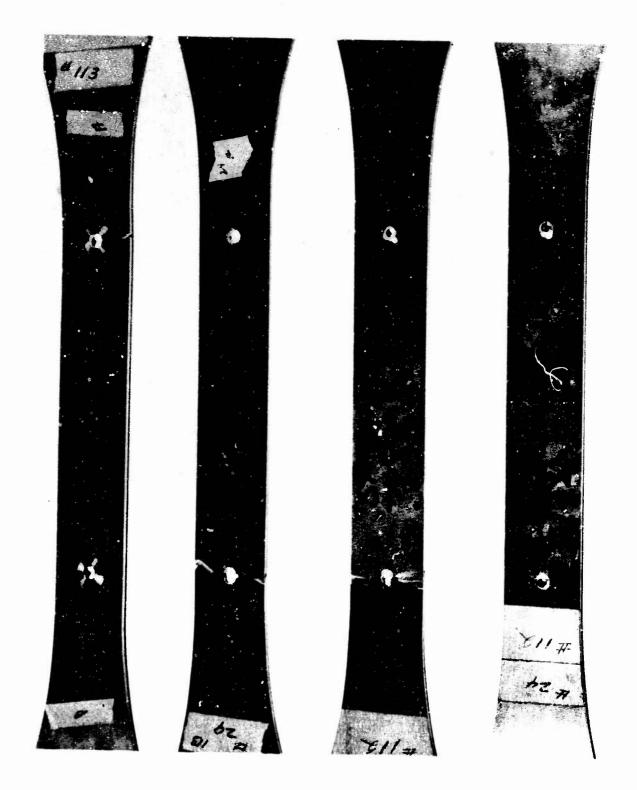
Figure 89. Typical Titanium Specimen Failures.

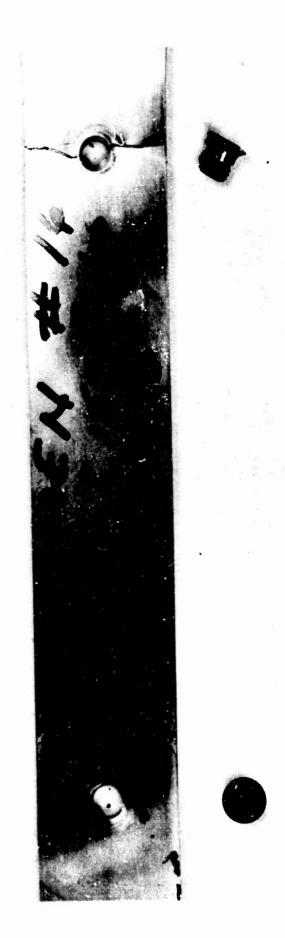
Figure 90. Typical Cracked Two-Hole Specimen,

cycles due to fretting between doubler and laminations. An additional 2.409 x 10⁶ cycles were accumulated before complete failure occurred.

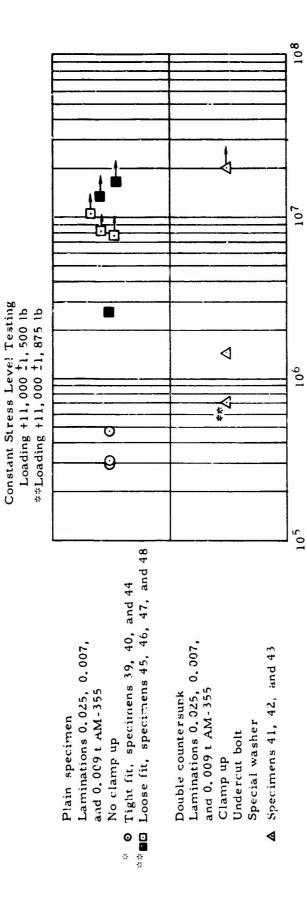
*Specimens 39 and 46 were of all the 0.007 t AM-355 laminations
***Increased loading on specimens 45, 46, 47, 48, and 43 to +11,000 ±1,875 lb

Figure 91. Four-Hole Root-End Attachment-Type Specimen.

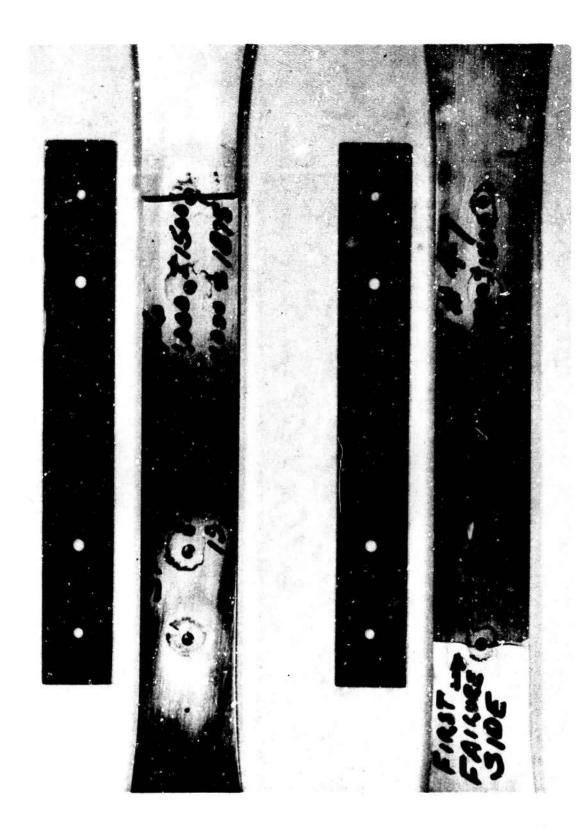
Figure 92. Typical Cracked Four-Hole Specimen.

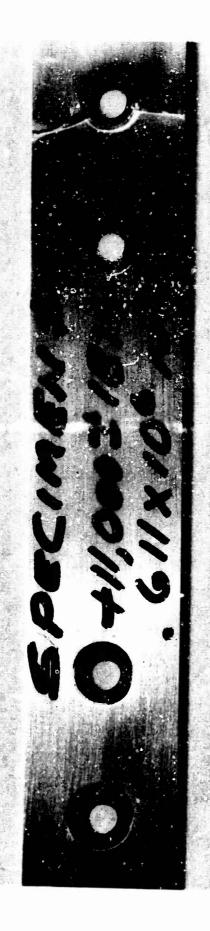
Figure 93. Typical Cracked Four-Hole Countersunk Specimen.

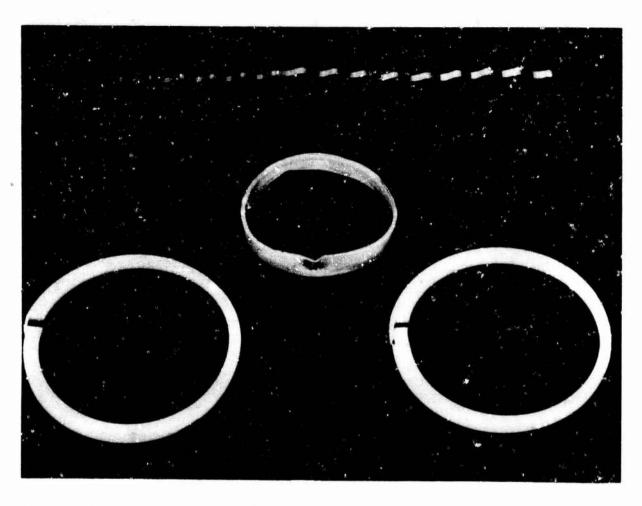
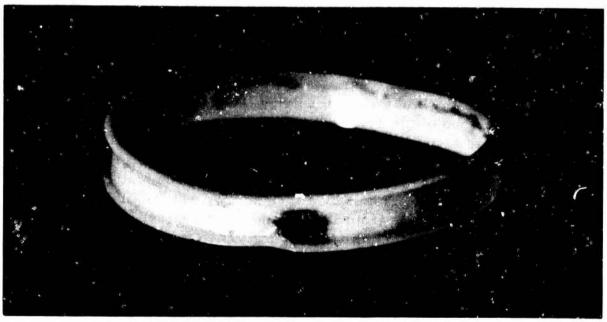
Figure 96. Damaged Seals.

1. Use of a different seal on the main pistons. A rubber-backed teflon slipper ring, such as used for the piston rod seal, is recommended.

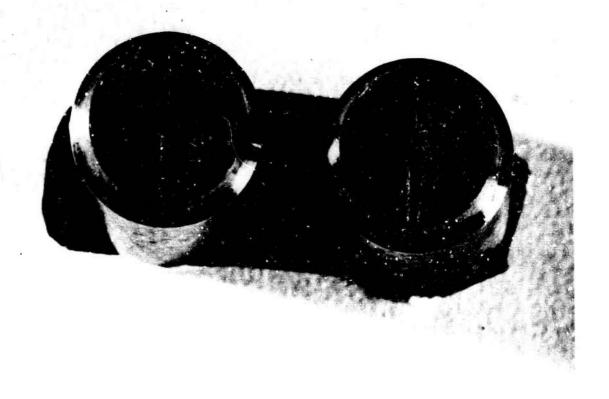
It was also found that the steel pin holding the piston to the piston rod on the tailstock end of the cylinder had broken during the 50,000-cycle overcoming load test. This pin had been observed to be in satisfactory condition during the previous disassembly at the manufacturer's facility. Functionally, this pin passes through holes in the piston and piston rod, and is held in place by a lock screw, which is threaded into the piston 90 degrees from the pin and rests against a necked-down portion at the center of the pin (see Figure 97). Ordinarily, only shear loads are carried by the pin, and those loads would be at the intersection of the piston rod and the piston.

Figure 97. Broken Pin.

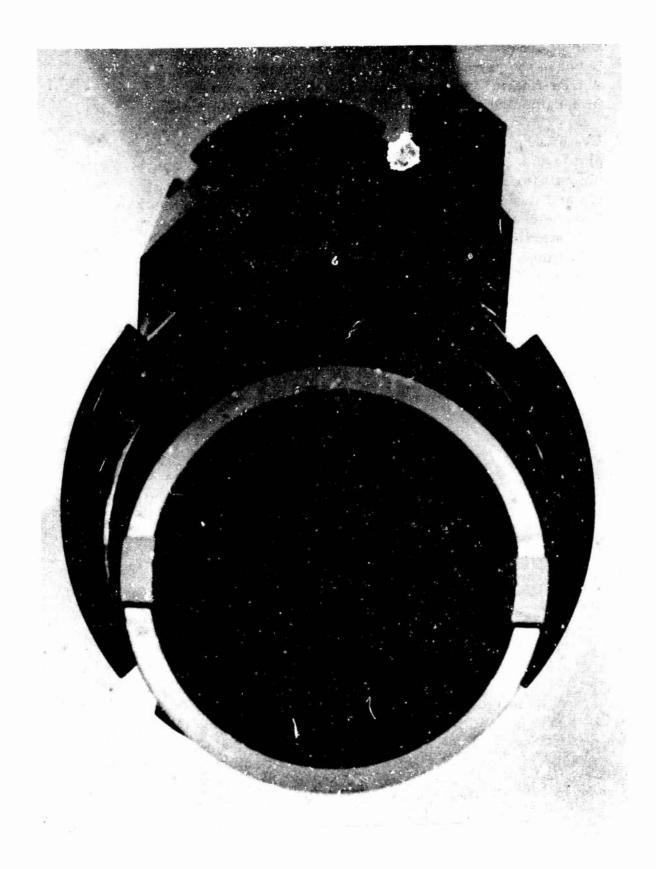
Figure 98. Cylinder Wall.
